## PROJECT FACT SHEET

**Customer:** Veolia

**Project:** Sydney Desalination Plant De-Energised Service

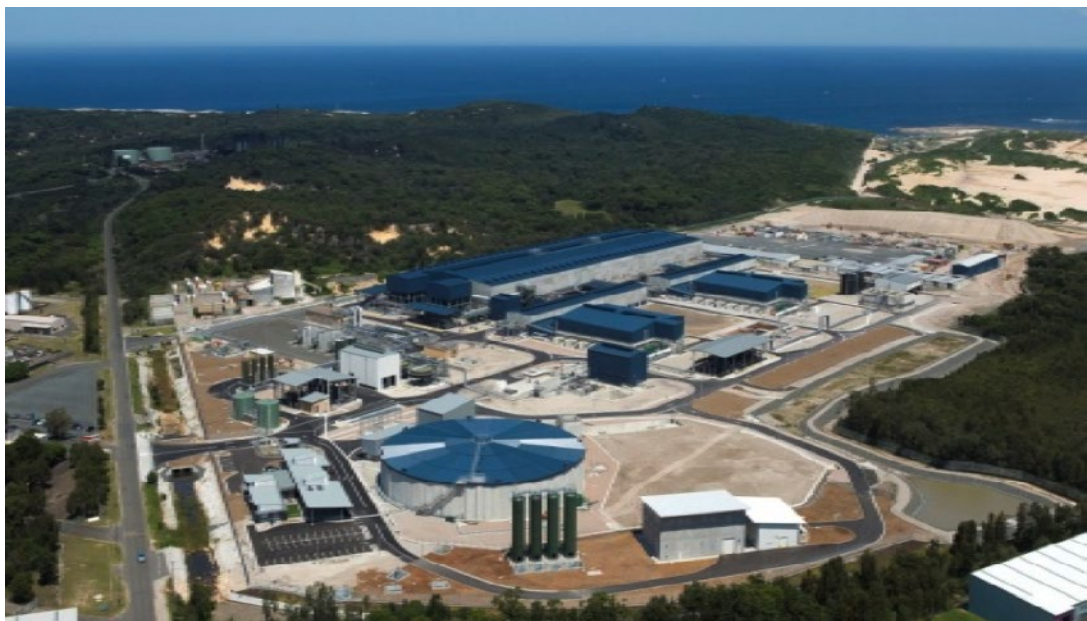
For the past six weeks Nilsen Engineering Services technicians have been working on a major program of HV and LV de-energised service for Veolia at the Sydney Desalination Plant.

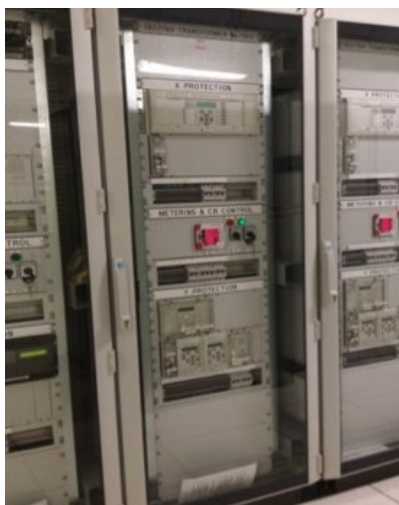
### **132Kv Protection**

On the HV side this has included de-energised service on three 132kv transformer protection relays unit, one 132kv busbar protection relay unit and one 132kv incomer protection relay unit. Testing included transformer differential, HV overcurrent, earth fault, line differential functions, CB Fail, and trip testing the relays.

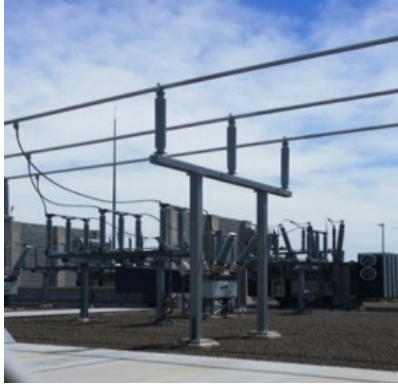
### 132Kv Switch Yard

The site 132kv switchyard was scanned using TEGG Basic Program which includes the use of a telescopic lens and the ultrasonic probe. All test results being documented in the TEGG pro software. Base lines were taken and will be compared to on the next visit.

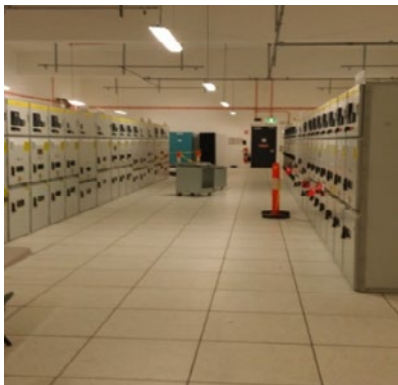
### 11Kv Switch Room

Inside the plants HV switch rooms Nilsen technicians have serviced sixty four Gelpag 11kv Vacuum circuit breakers and tested sixty one SEPAM protection relays. The works included visual inspections, injection testing, functionality and trip testing, re lubricating, resistance and insulation testing.

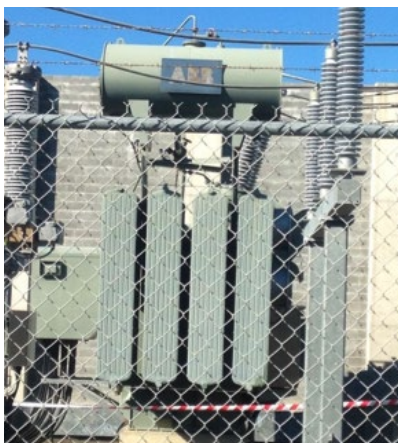
### 11Kv Transformers

In addition to the above the TEGG basic program has been used and ultrasonic and infrared scanning was undertaken on thirty two 11kv transformers.

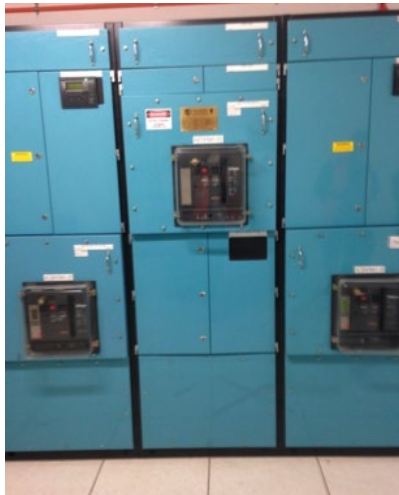
### LV Switch Boards

On the low voltage side our technicians have serviced sixty seven LV Schneider Masterpact ACBs. In addition our team has completed full functionality testing on a total of twenty two earth leakage relays and full busbar resistance testing.

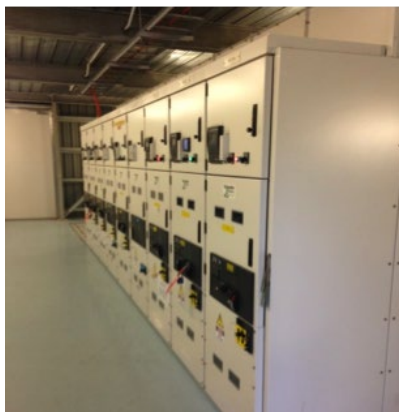
### Drinking Water Pump Station HV

In addition technicians have serviced the drinking water pump station which controls water leaving the desalination plant. This service included eleven Schneider 11kv vacuum circuit breakers and ten SEPAM protection relays. The works included visual inspections, injection testing, functionality and trip testing.

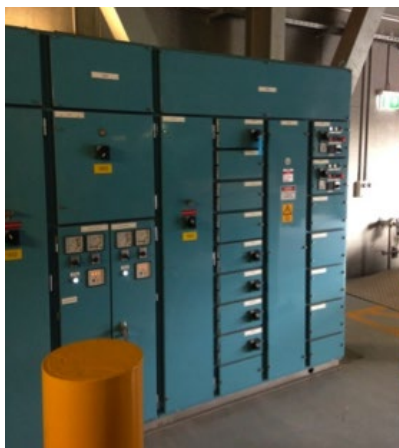
### Drinking Water Pump Station LV

Nilsen technicians have serviced the drinking water pump LV MCC switch board including Infrared and Ultrasonic testing prior to servicing MCCB's Isolators, VSDs. The works included visual inspections, injection testing, functionality and trip testing, re lubricating, resistance and insulation testing.
