PROJECT FACT SHEET

Customer: Veolia

Project: Sydney Desalination Plant De-Energised Service

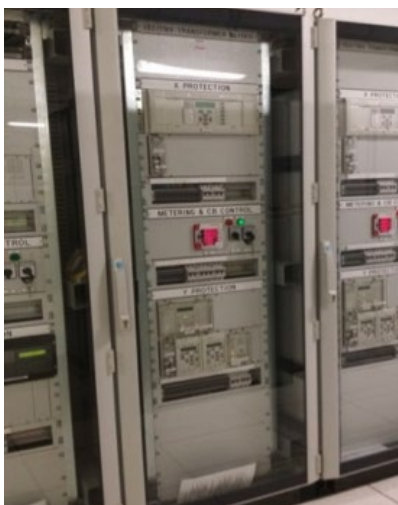
132Kv Protection

On the HV side this has included de-energised service on three 132kv transformer protection relays unit, one 132kv busbar protection relay unit and one 132kv incomer protection relay unit. Testing included transformer differential, HV overcurrent, earth fault, line differential functions, CB Fail, and trip testing the relays.

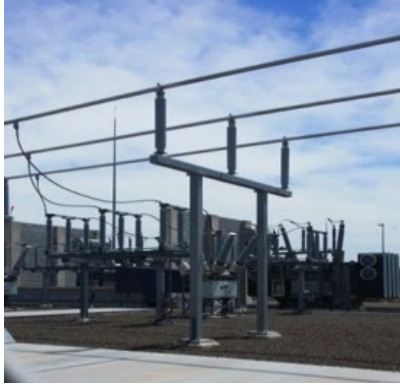
132Kv Switch Yard

The site 132kv switchyard was scanned using TEGG Basic Program which includes the use of a telescopic lens and the ultrasonic probe. All test results being documented in the TEGG pro software. Base lines were taken and will be compared to on the next visit.

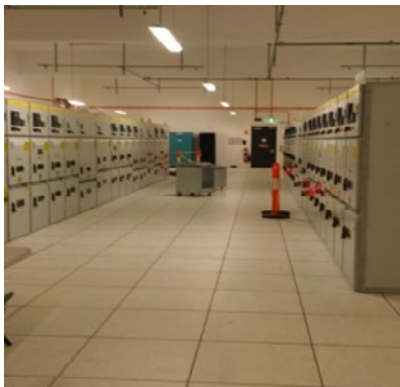
11Kv Switch Room

Inside the plants HV switch rooms Nilsen technicians have serviced sixty four Gelpag 11kv Vacuum circuit breakers and tested sixty one SEPAM protection relays. The works included visual inspections, injection testing, functionality and trip testing, re lubricating, resistance and insulation testing.

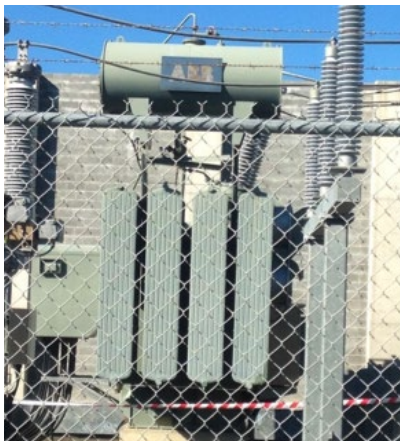
11Kv Transformers

In addition to the above the TEGG basic program has been used and ultrasonic and infrared scanning was undertaken on thirty two 11kv transformers.

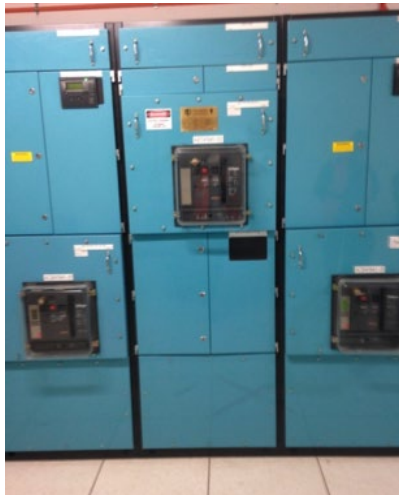
LV Switch Boards

On the low voltage side our technicians have serviced sixty seven LV Schneider Masterpact ACBs. In addition our team has completed full functionality testing on a total of twenty two earth leakage relays and full busbar resistance testing.

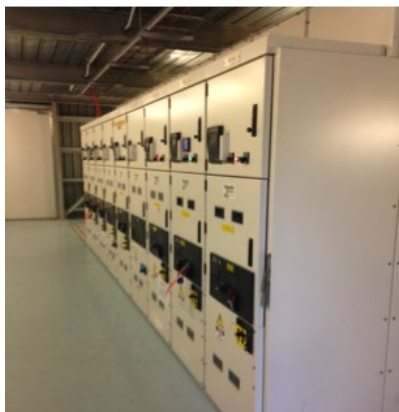
Drinking Water Pump Station HV

In addition technicians have serviced the drinking water pump station which controls water leaving the desalination plant. This service included eleven Schneider 11kv vacuum circuit breakers and ten SEPAM protection relays. The works included visual inspections, injection testing, functionality and trip testing.

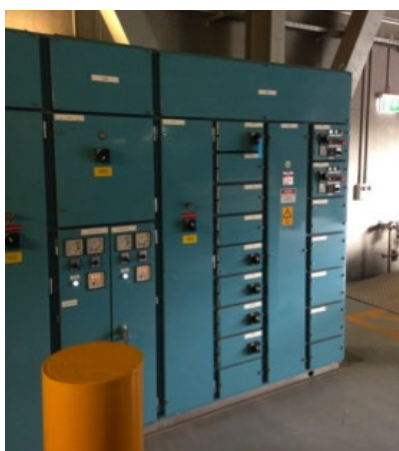
Drinking Water Pump Station LV

Nilsen technicians have serviced the drinking water pump LV MCC switch board including Infrared and Ultrasonic testing prior to servicing MCCB's Isolators, VSDs. The works included visual inspections, injection testing, functionality and trip testing, re lubricating, resistance and insulation testing.
